BLACKWELL HOUSE

FEASIBILITY STUDY

May 27, 1988

Restoration Feasibility Study
Preliminary Report
May 27, 1988

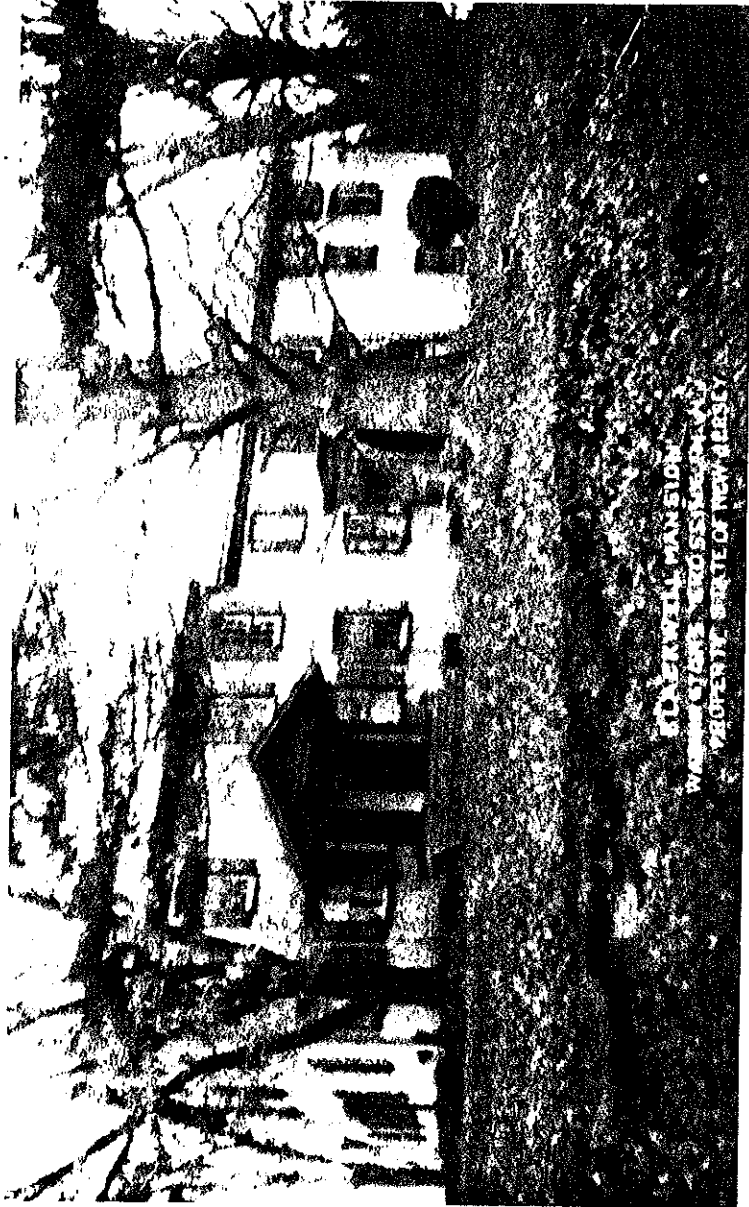
Plate 1 - "Blackwell Mansion" circa 1915. From a postcard of the period.

The earliest known photograph, c. 1915 (Plate 1), shows shutters on all three sections and Victorian porches on the central and western sections. In the twentieth century the porches were renovated with some Colonial Revival details (pl. 2), and small shed additions were added on the rear to the first floor of the eastern section and the second floor of the western section.

Condition- The house previously had shutters, as visible in the 1915 photograph (Pl. 1), which contributed significantly to its overall appearance. The ground floor appears to have had panel shutters, while the second floor had louver shutters. They are all missing, although shutter hardware remains on several windows.

Condition- The 1915 photograph (PL. 1) shows a polychrome paint scheme on the shutters and wood trim. The current paint colors on the wood trim are inappropriate for the building's historical significance. The entire building currently needs to be repainted.

The porches should be restored to the building's period of historical significance. The design that is visible in the 1915 photograph (Pl. 1) appears to date from this period. The photograph provides much of the architectural evidence needed for restoration, particularly for the western porch. Details, such as molding profiles and dimensions of members, could be obtained from surviving examples of this design and from pattern books of the period.

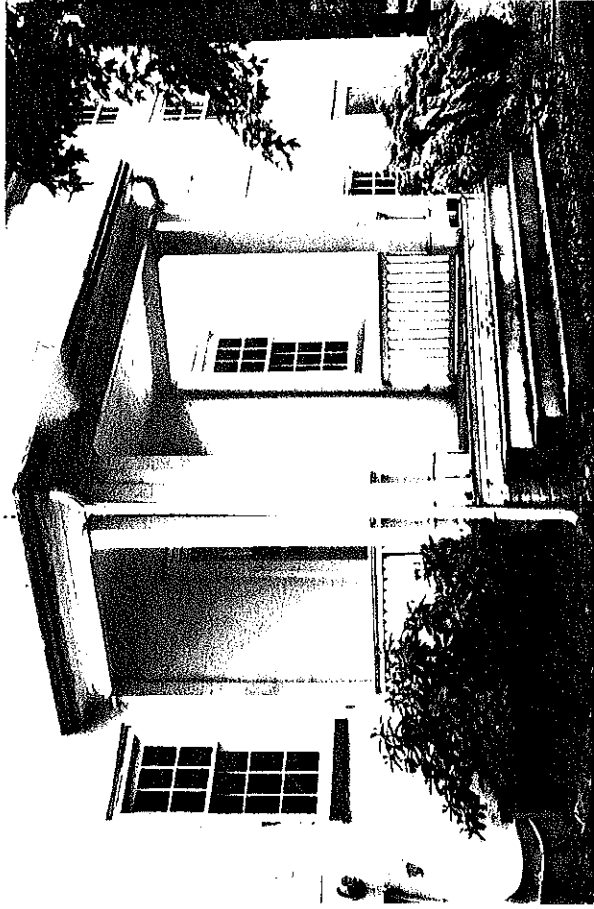
Plate 3 - South facade, eastern porch.

Condition- The eastern porch (Pl. 3) appears to have the same roof visible in the 1915 photograph (Pl. 1). The cornice moldings (Pl. 4) and floor structure indicate that it was probably constructed in the late nineteenth century. The columns, which are placed in groups of three at each corner as typical in Colonial Revival design, appear to have been installed in the twentieth century. The bases of the columns and portions of the floor structure and decking are severely rotted (Pl. 5), with the result that the porch roof could collapse. A leak in the roof appears to have deteriorated a portion of the porch cornice.

Recommendation- Because of their deterioration, major portions of the columns, decking, and steps will have to be replaced. As nearly all of these elements are modern replacements, they have little historical value and should not be replicated in their current design. Instead, the extensive renovations that are now required present the opportunity for appropriate historical treatment of these prominent details, which are on the front of the building and are visible from Pennington-Washington Crossing Road.

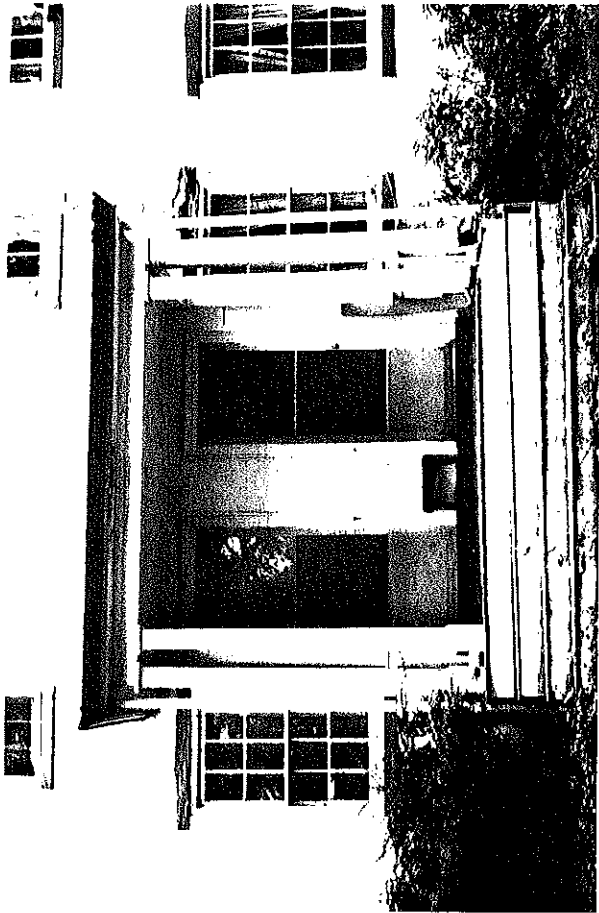
Plate 6 - South facade, western porch.

The western porch roof, columns, decking, and steps (Pl. 6) appear to have been built in the twentieth century. The floor structure, however, may date to the earlier gable roof porch visible in the 1915 photograph (Pl. 1). The column bases and portions of the decking and steps (Pls. 7 & 8) are severely rotted like those on the eastern porch, and this porch roof could also collapse. Leaks in the roof have caused some rot around the soffit of the cornice (Pl. 9).

Recommendation- The aluminum doors on the south facade (Pl. 6), detract from the historic appearance of the house. They should be removed and replaced with full-glass storm doors, painted to match the wood trim.

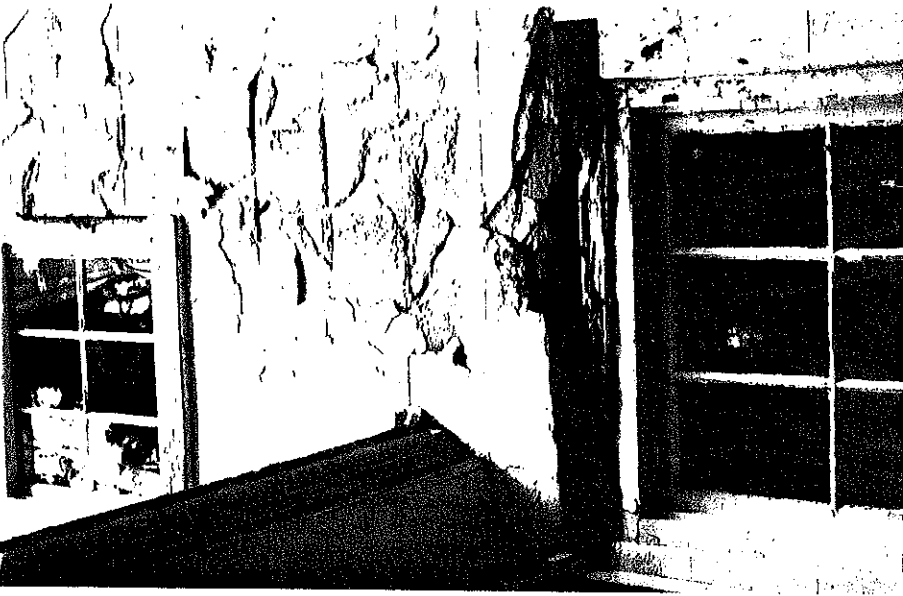
Plate 10 - South facade, western section,
stucco and lintel.

Condition- The original stucco, visible on the facade of the western section above the rotted window lintel (Pls. 10, 11, 12, 13), appears to be a sandy material in color and texture with horsehair as a binder. The stucco in patched areas is harder and grayer, indicating a high proportion of portland cement. The stucco on the south facade, west side, and portions of the north and east sides was struck with lines to imitate the coarsing of ashlar stone masonry. Whether or not earlier stucco on the central and eastern sections was struck with coarsing lines would have to be determined by exposing a sampling from these sections. With the exception of the areas where penetrating water has caused damage, most of the stucco appears to be intact.

Condition- On the western section of the south facade, the leaking gutter has caused extensive deterioration to the first floor window east of the porch (Pls. 10 & 12). Most of the window sash and frames are original to each construction period and are in fair to good condition. Typical deterioration includes missing, cracked, or loose glazing, peeling paint, and some cracks in sills or along masonry joints which allow water penetration (Pls. 21 & 22).

Recommendation- The sections in good condition, which constitute the majority of the building, should remain since they are providing good protection for the stone masonry beneath. Where the stucco has failed and needs to be patched, it should be analyzed to determine the original composition. Replacement stucco should replicate the original in texture and hardness, using a bonding agent to promote adhesion. Coarsing lines should be struck to continue the current pattern over the patched areas.

Recommendations- The missing lintel fascia and rotted lintel on the first floor window should be replicated and installed to ensure durability and structural support. The sash should be reglazed where necessary, with care taken to preserve the original glass. Sills and frames should be caulked and sealed where necessary to prevent moisture damage.

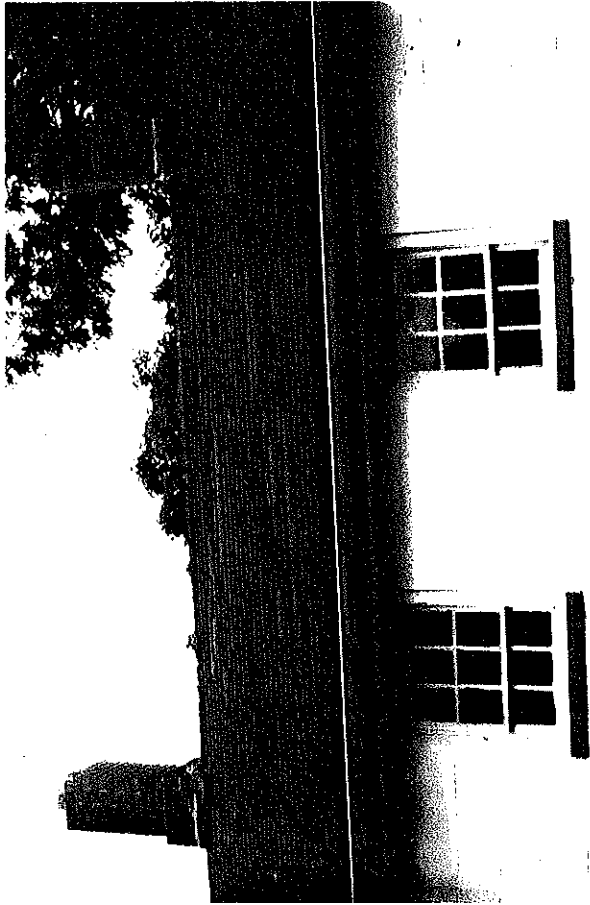
Plate 14 - South facade, eastern section,
roof and chimneys.

Condition- The asphalt shingle roofs are beginning to show signs of deterioration (Pl. 14), and patches have been made in several areas. One leak was evident in those areas of the attic that were inspected, and many shingles have broken off on the southern portion of the roof. There appears to be a leak on the one-story rear addition to the western section (Pl. 15), which is causing plaster and paint failure in Apartment C.

Recommendation- While the service life of the existing roofs could be extended through patching, the best solution would be to replace them. This will facilitate needed repairs to the gutters and flashing, and avoid the need for repeated repairs. In keeping with the house's historic character, the new roofing material should be cedar shingles.

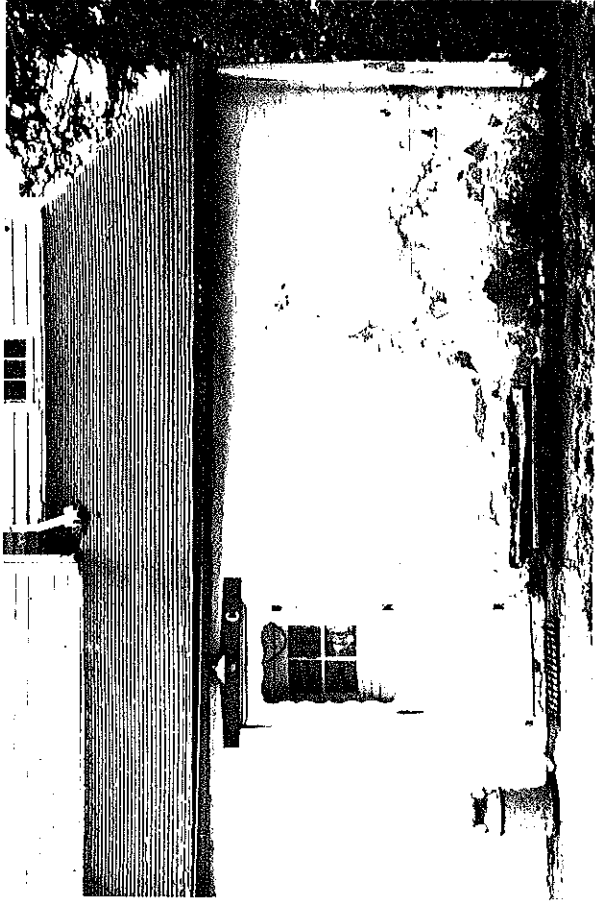
Plate 15 - North side, western section
leaders, gutters, and
roofing.

Condition- The hanging gutters are generally clogged with debris. About half the gutter along the first story of the north side of the western section is missing (Pl. 15).

Recommendation- The rotted hanging gutter on the north side should be replaced and the gutters on the eastern and central sections should be repaired and maintained as required. An alternative would be to replace the hanging gutters in copper, which would require no painting and last longer than galvanized gutters. Screens should be provided in the scupper holes and periodically maintained.

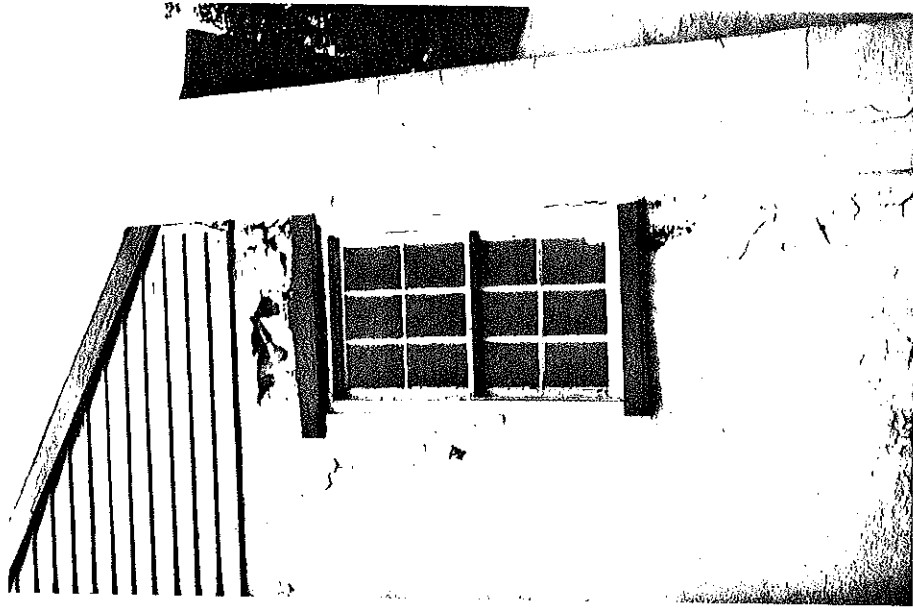
Plate 18 - Western section, east side,
chimney.

Condition- The stuccoed chimnies on the western section appear to be in generally good condition (Pls. 18 & 19), with the exception that some of the flashing needs repair or replacement as water has caused some paint deterioration. The brick chimney caps on the central and eastern section have been rebuilt, probably when clay flue liners were installed. Some of the pointing is missing and portions of the flashing need repair (Pl. 14). The eastern chimney, which is not being used to vent heating equipment, is allowing moisture to enter the stone masonry on the eastern gable, causing paint failure (Pl. 20).

Recommendations- The flashing on all the chimnies should be repaired or replaced as necessary when the roof is replaced. Replacement with copper would require minimal maintenance in the future. The brick chimney caps should be repointed with mortar that replicates the original mortar in color, hardness, and tooling. The eastern chimney should be capped to prevent moisture from entering the walls.
