BEAR TAVERN
Washington Crossing State Park
Washington Crossing, New Jersey

PHASE 1: c. 1790

Schematic Interpretation, No Scale

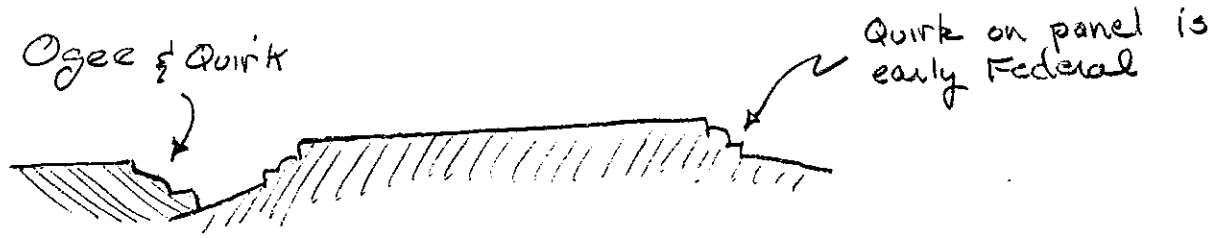
Corner Copboard

cupboard cornice

rounded back

cast hinges

c. 1790 - 1810

The front room appears to have been the original kitchen/living room. It retains a large fireplace (now blocked), closet stairs leading to the cellar and second floor, and a good quality corner cupboard. The cupboard is original, as the wall behind it has never been plastered. The first floor ceiling joists are chamfered and the undersides of the floor plank above are edge beaded.
