BLACKWELL HOUSE

FEASIBILITY STUDY

May 27, 1988

Restoration Feasibility Study
Preliminary Report
May 27, 1988

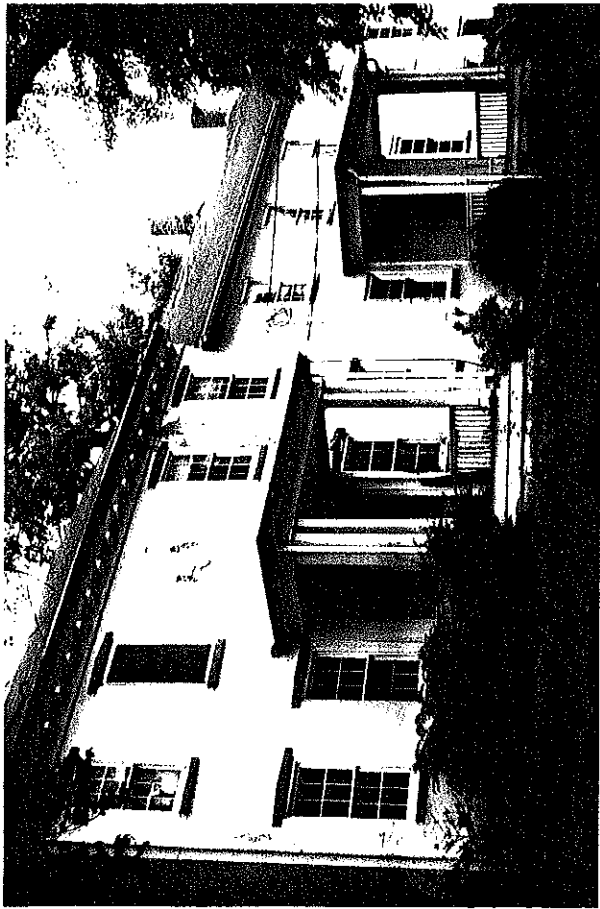
Plate 2 - South facade.

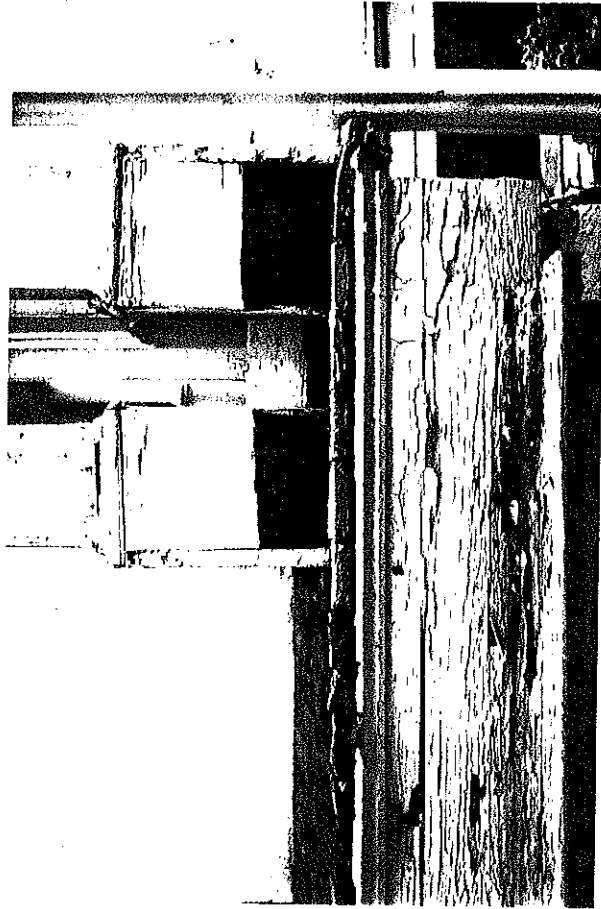
Condition- The eastern porch (Pl. 3) appears to have the same roof visible in the 1915 photograph (Pl. 1). The cornice moldings (Pl. 4) and floor structure indicate that it was probably constructed in the late nineteenth century. The columns, which are placed in groups of three at each corner as typical in Colonial Revival design, appear to have been installed in the twentieth century. The bases of the columns and portions of the floor structure and decking are severely rotted (Pl. 5), with the result that the porch roof could collapse. A leak in the roof appears to have deteriorated a portion of the porch cornice.

Plate 5 - South facade, eastern porch,
east column bases.
