### Outpatient Surgery Center

## Outpatient Surgery Center Solves HVAC Issues with Aeroseal

#### Maisonneuve-Rosemont Hospital – Rosemont Pavilion

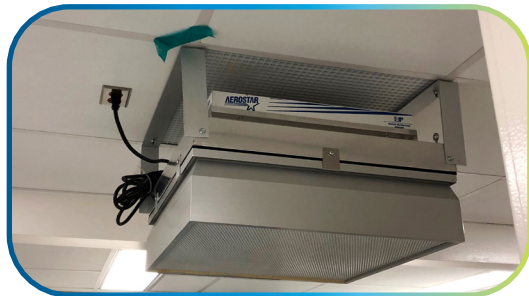
Air quality was also being reduced due to contaminants from ceiling plenums getting into the ductwork and then being distributed into interior spaces. Additional filtration units were installed at supply vents to achieve the necessary indoor air quality.

Filtration Unit Installed Below Supply Air Vent

Upon completion of the Aeroseal duct sealing, all operating rooms are able to achieve their required positive pressure differential to adjacent spaces, and the air filtration units that were being used at supply vents to remove contaminants in the air stream were no longer needed and were removed.

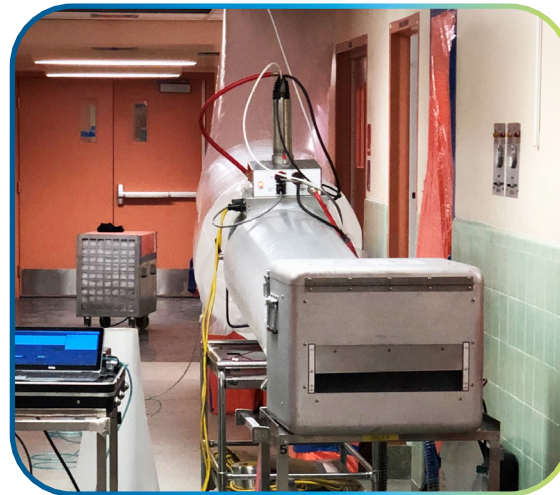
The ductwork for each of several air handling units was sealed, with the existing leakage confirmed for each segment of ductwork as work began. Aeroseal's automated system runs a continuous duct pressurization test, reporting air leakage every 60 seconds so that the system

technician can track progress and achieve the lowest duct leakage possible.

Aeroseal Equipment Sealing Ductwork

The ductwork was sealed over 4 days, from Friday through Monday, substantially shorter than the 6 months proposed for manual duct sealing. Air scrubbers were used in some spaces to ensure that sealant would not cause any issues where sealing was being done.
